An Education Program “Building Pathology for Timber Architecture”

Prof. Fumiko MISAWA
Dean, School of Timber Architecture
The Gifu Academy of Forest Science and Culture
Mino, Japan
Dr. Keiko HIROTA
Research Associate
Centre for Health Assets Australasia, The University of New South Wales
Sydney, Australia

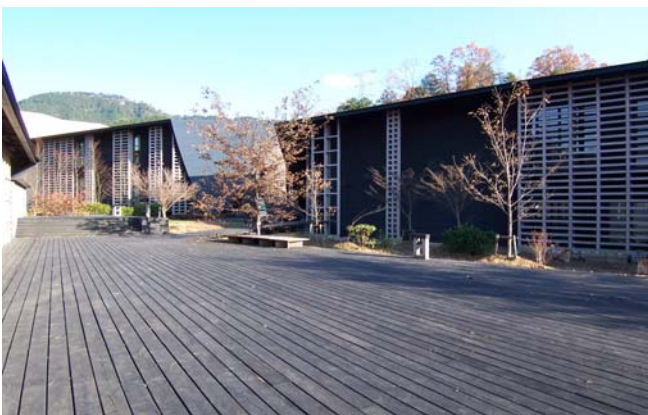
Fig. 1 Gifu Academy Building Facilities

The facilities of the Gifu Academy is famous for the timber design, and the surface of this school is covered with full of timber surfaces and details (Fig.1). Therefore the building maintenance and management have been crucial issues to Gifu Academy from the beginning. The architecture education programs were designed to deal with such issues directly with some curriculum focused on the actual maintenance process. The second study theme is Mino city, an ancient Japanese merchandise city famous for traditional papers since sixth century (Fig.2). The local residents

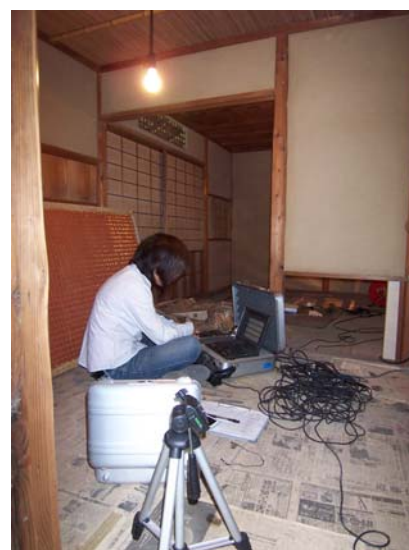
Fig.4 Structural Assessment: Micro-Tremor Test

Assessment Criteria	Equipments
Building Conditions	Surveying instrument: Transit
Materials	Water content measure: for timber and concrete
	Digital camera
	Spot lighting system
	Claw hammer
	Tape rule
Structure	Geological survey test kit: SS kit
	Micro-tremor monitor
	Digital gradient monitor: Smarttool
Indoor Climate	Digital camera
	Data Logger (room temperature and humidity)

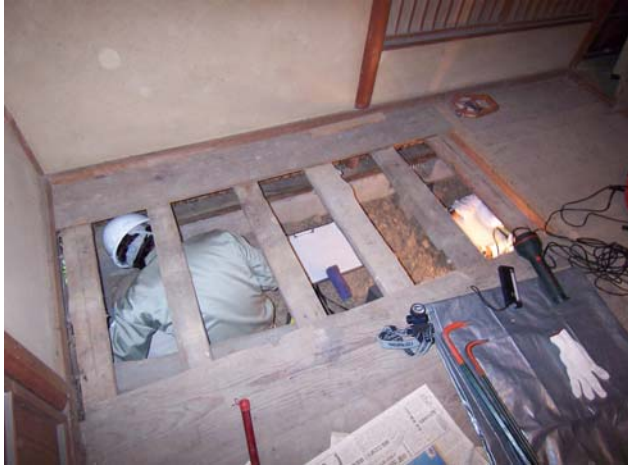
Fig.5 Floor Assessment

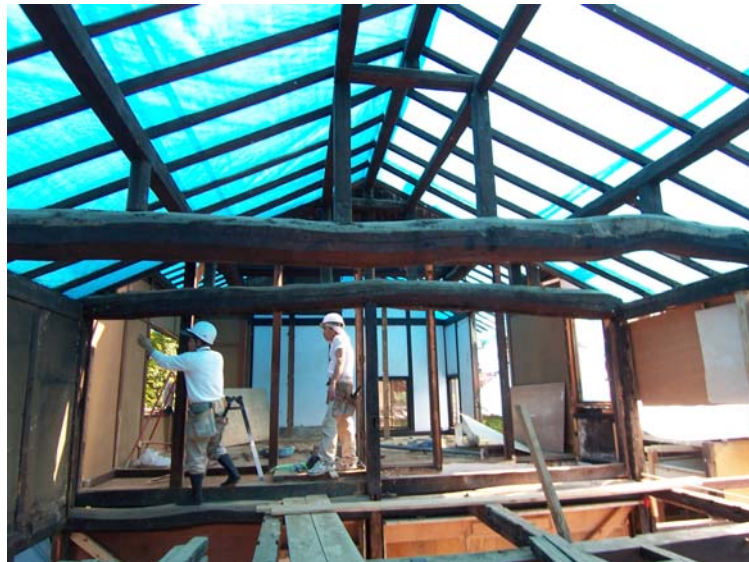
Fig.7 Student Construction Site for Timber Housing in Mino City

The following process of defect solution, design application and holistic building conservation plan are programmed as a local building conservation curriculum (Fig.7). The methods and the outcomes are designed to be feedback and input into the building pathology curriculum later.
